MAINTENANCE WELDING IN NUCLEAR POWER PLANTS III

Maintenance Welding in Nuclear Power Plants III was held at Knoxville, Tennessee, November 6-8, 1985. The purpose of this conference was to provide participants with the current developments and trends in this important segment of the welding industry and to help attendees understand and obtain an international perspective of these trends from a global roster of speakers and participants.

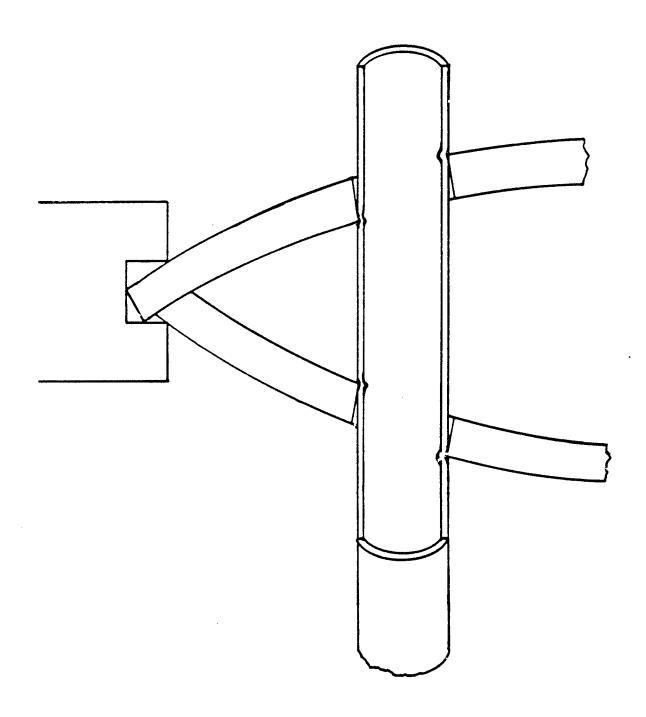
FIGURE 1. DINGING OF TUBE

The damage sustained by the steam generator tubing can generally be described as indentations. These were later termed "dings" to differentiate from the tube denting phenomenon. Tubes were "dinged" at support plate locations in the straight leg portion of the tube bundle as well at the U-bend supports. Dinging produced localized tube wall indentations and some local reduction in the inside diameter of the tubing. Figure 1 illustrates dinging of tube.

Inspection results showed that approximately twenty-five percent of the tubes were damaged, the peripheral tubes sustaining the most severe dinging. The damage depth was generally less than 0.5mm but a small number of tubes were shown to have damage depths as high as 1.0mm.

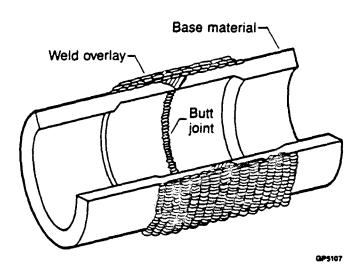
Cracks requiring repair are located in heat-affected zones of circumferential welds in stainless steel pipe. The overlay provides needed structural reinforcement where part-through circumferential cracks are present, and it prevents leakage from short, through-wall axial cracks that are less frequently encountered. Circumferential weld beads are applied in several layers, providing a buildup typically 1/4- to 1/2-inch thick and 2 to 8 inches in axial length. Figure 1 shows the essential features of a weld overlay.

Figure 1. Weld overlay repair technique for stress corrosion cracking.

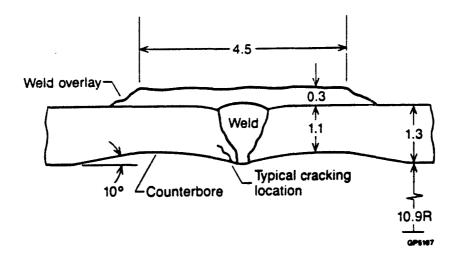
Figure 6. Weld overlay repair of a precracked 24-inch pipe.
